## UTAH 3809 COMPLIANCE INSPECTION REPORT

*Contract:* U-78598

*Project name:* Snow White Marble Quarry

*Date of Inspection:* November 23, 2010

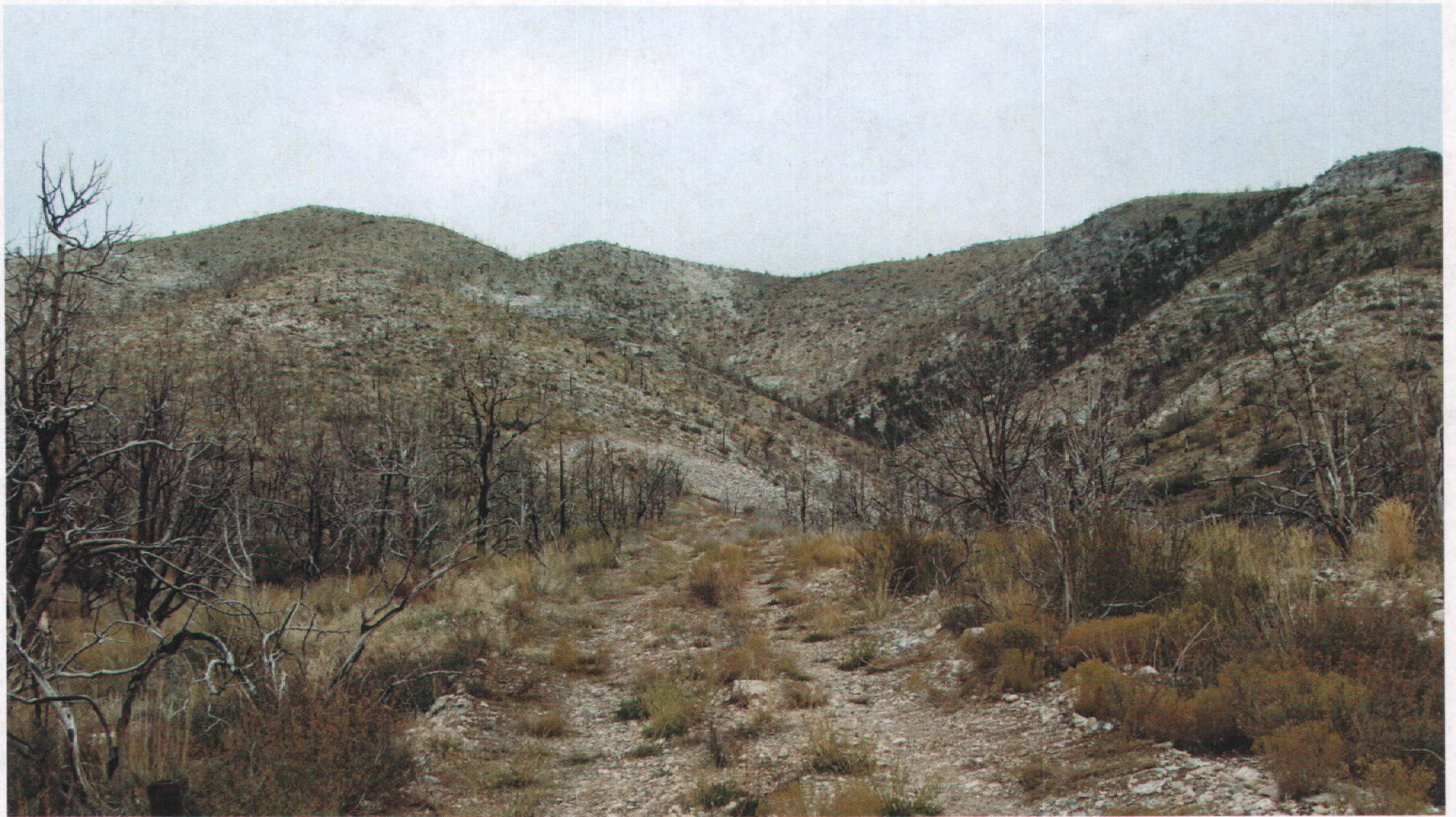
View of the reclaimed northern open-cut and access road showing abundant alfalfa, kochia, small burnet, wheat grasses growing on the access road.

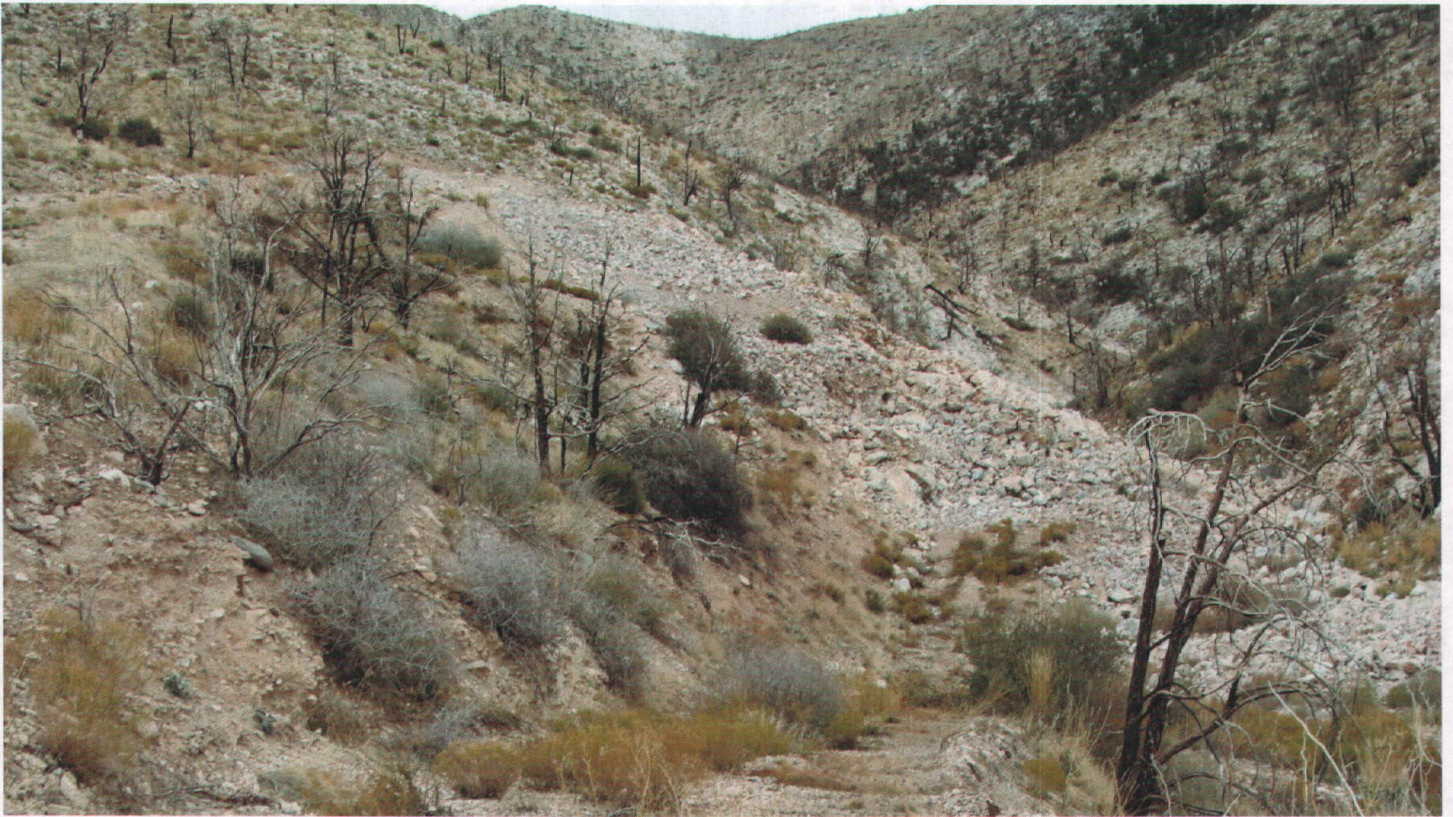
Closer view of the reclaimed northern open-cut and access road.

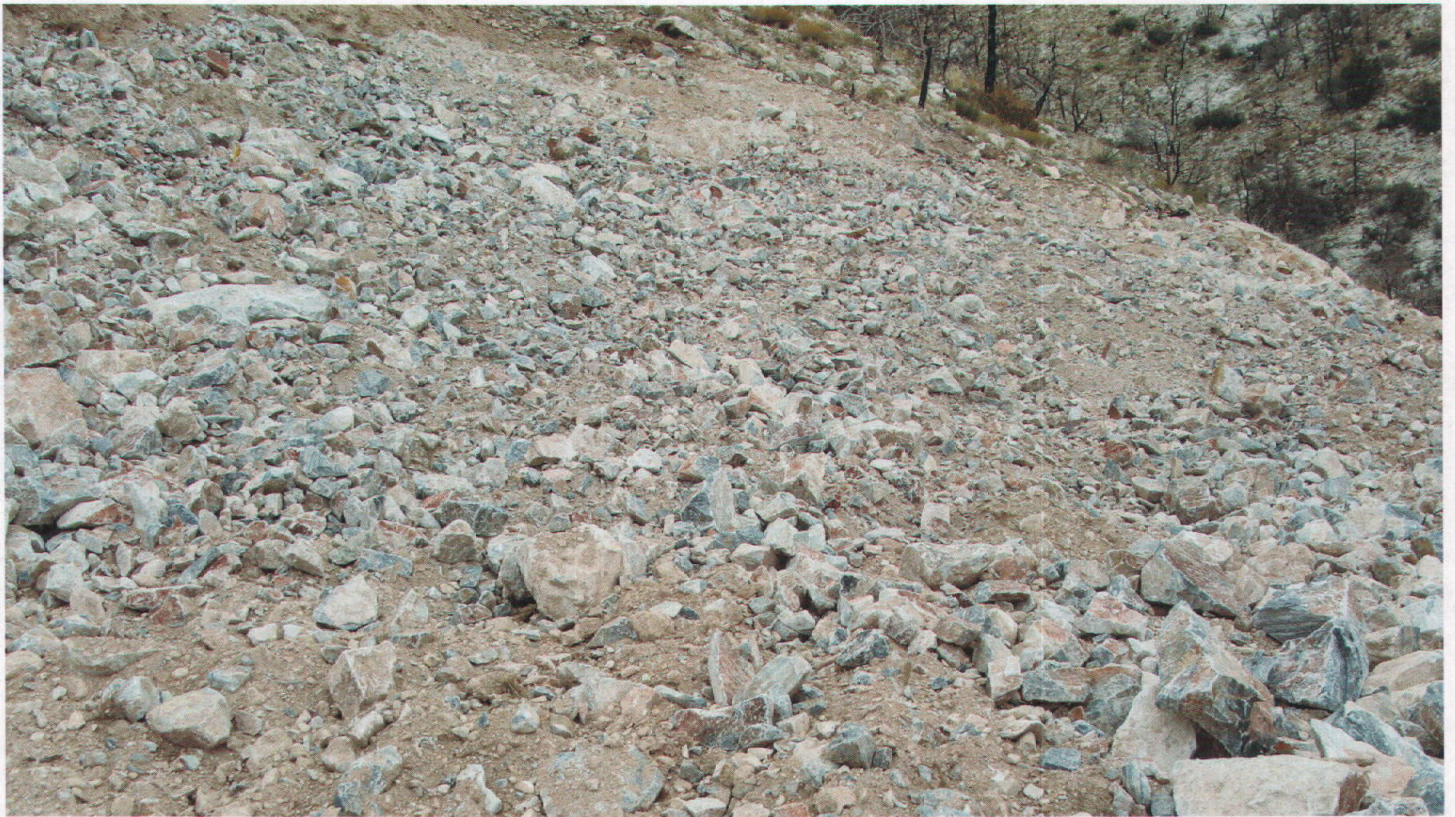
Close-up view of the reclaimed northern open-cut.

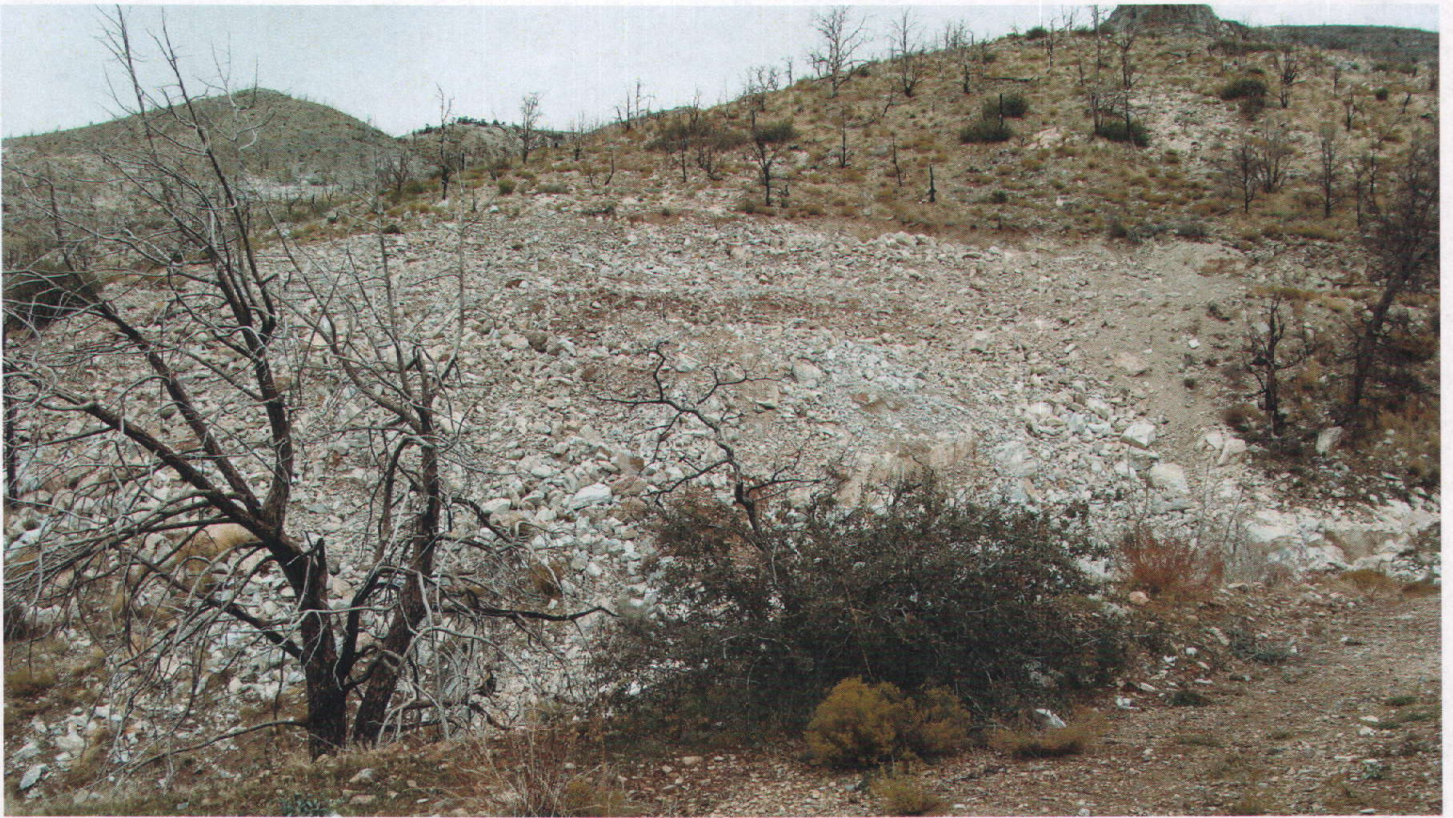
Close up of the reclaimed south open-cut (originally 15 ft wide by 60 ft long and up to 10 ft deep) in recrystallized limestone/marble.

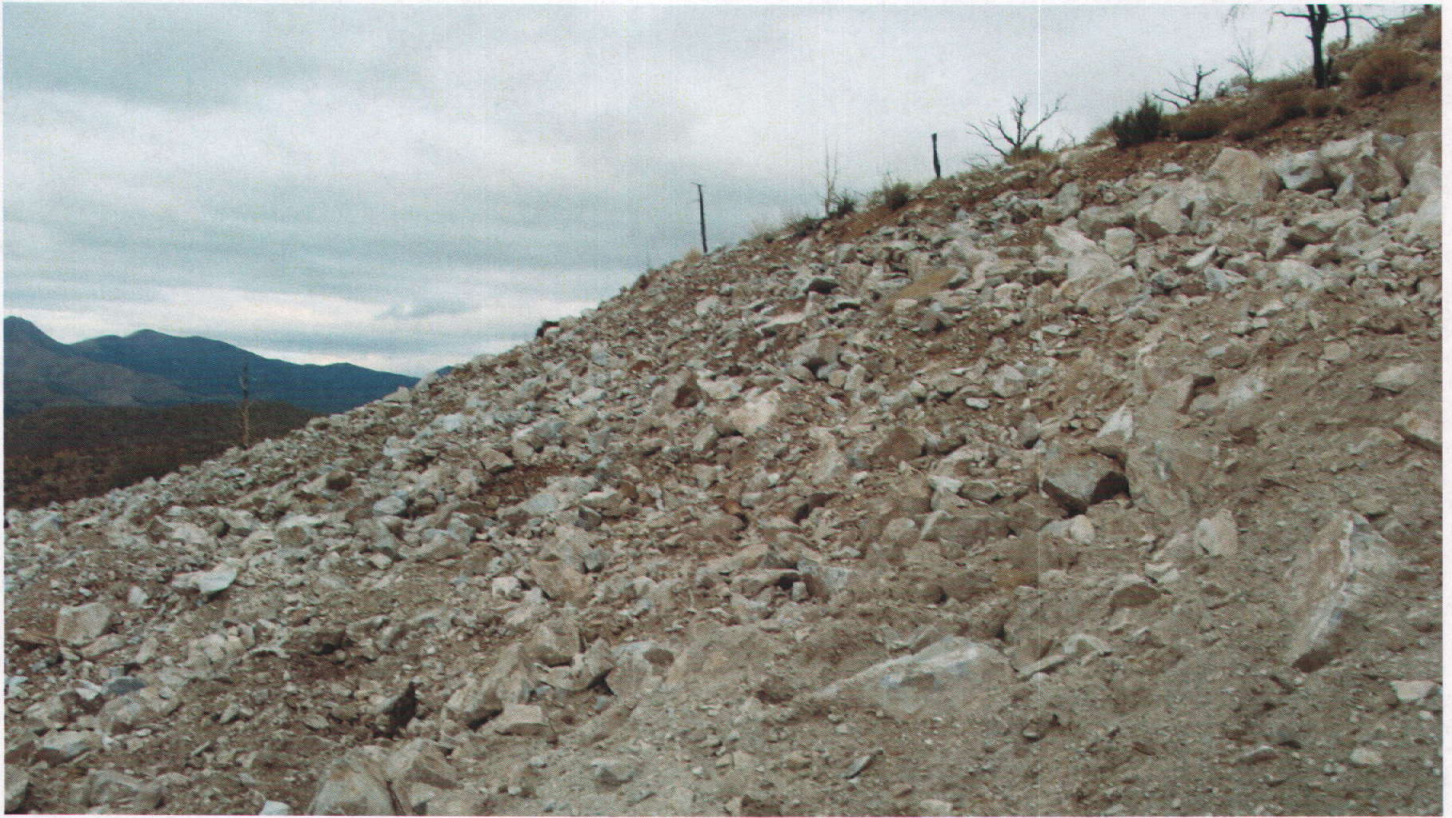
Close up of the reclaimed south open-cut in recrystallized limestone.

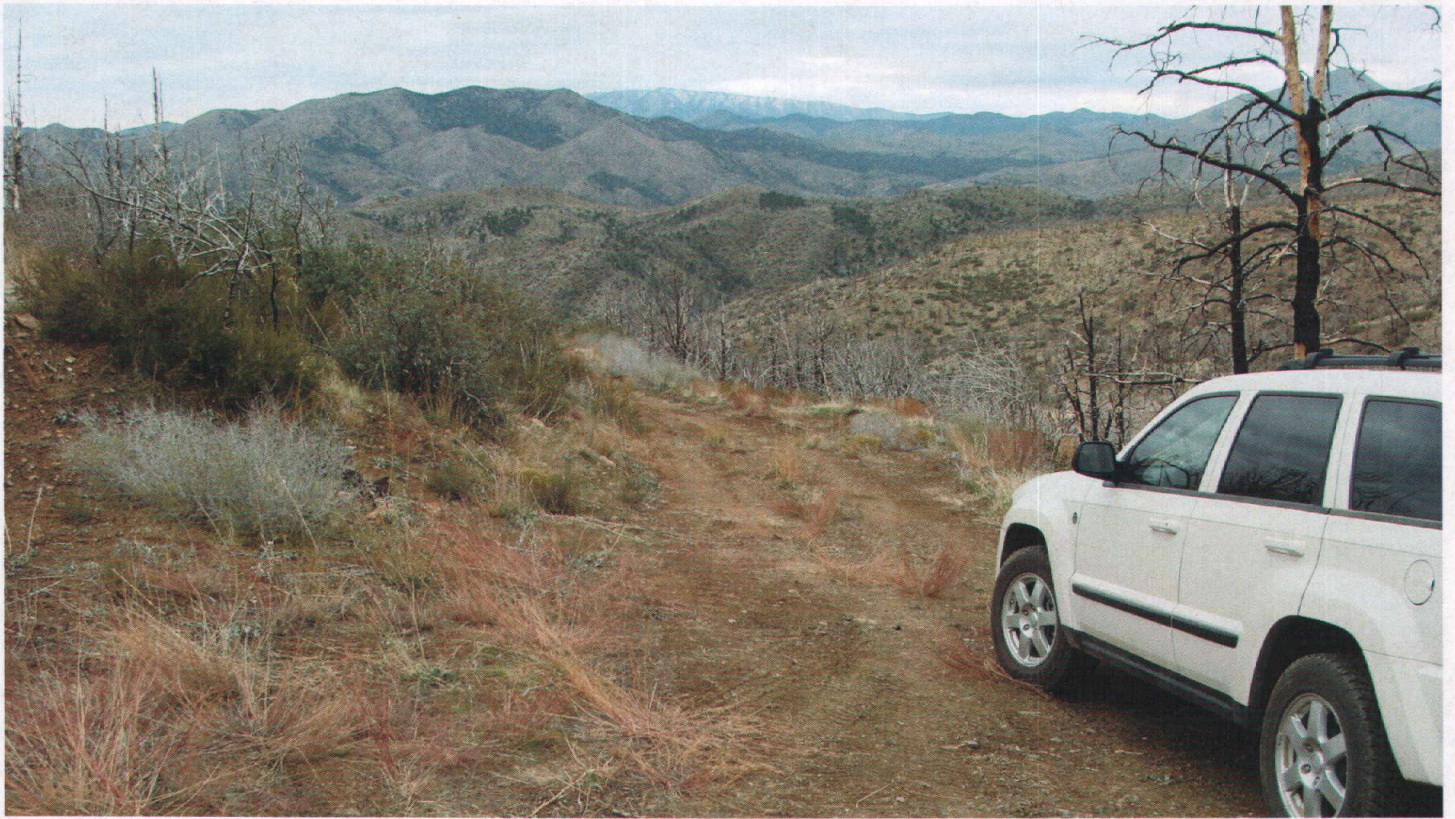
View of the southern open-cut access road from above.

*Instructions to Operator:* Reclamation of roads required/contacted operator on November 23, 2010.
